POST AUDIT REPORT

**Aditi Mahavidyalay
New Delhi**

Sugamya Bharat Abhiyan
(Accessible India Campaign)

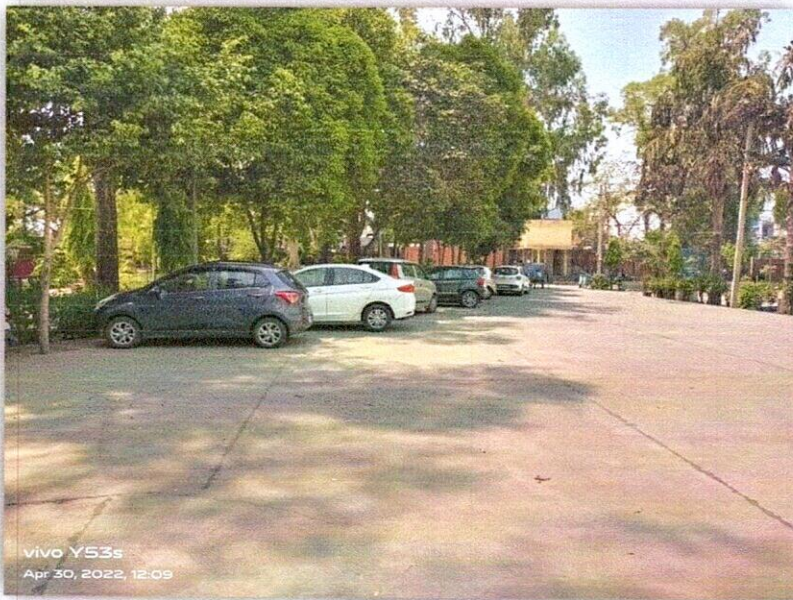
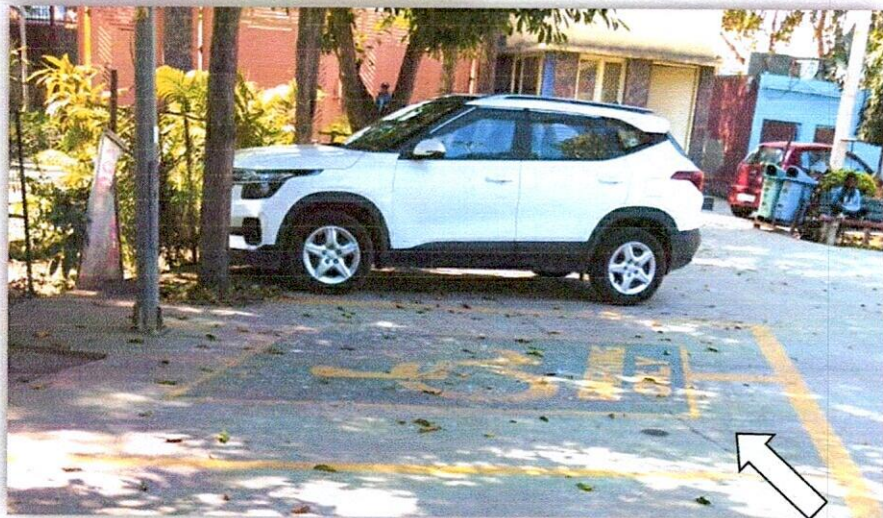
There is designated parking for staffs & visitors for two wheelers as well as four wheelers also after access audit there is reserved car or two wheeler parking for persons with disabilities as per the accessibility guidelines.

Accessible parking bay proposed near the Entrance

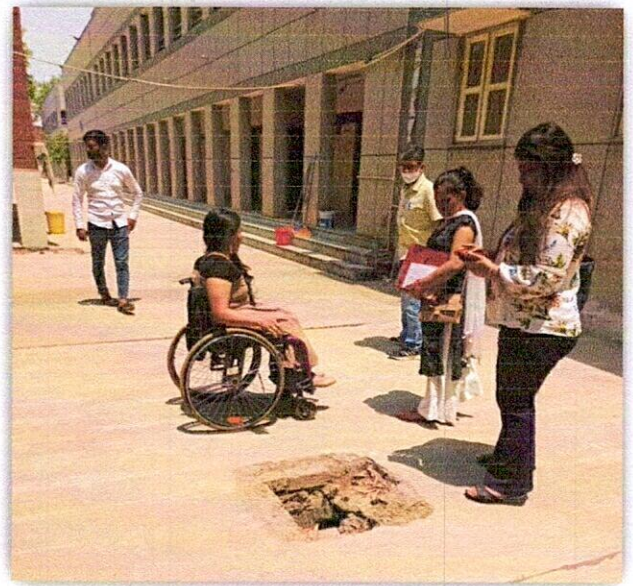
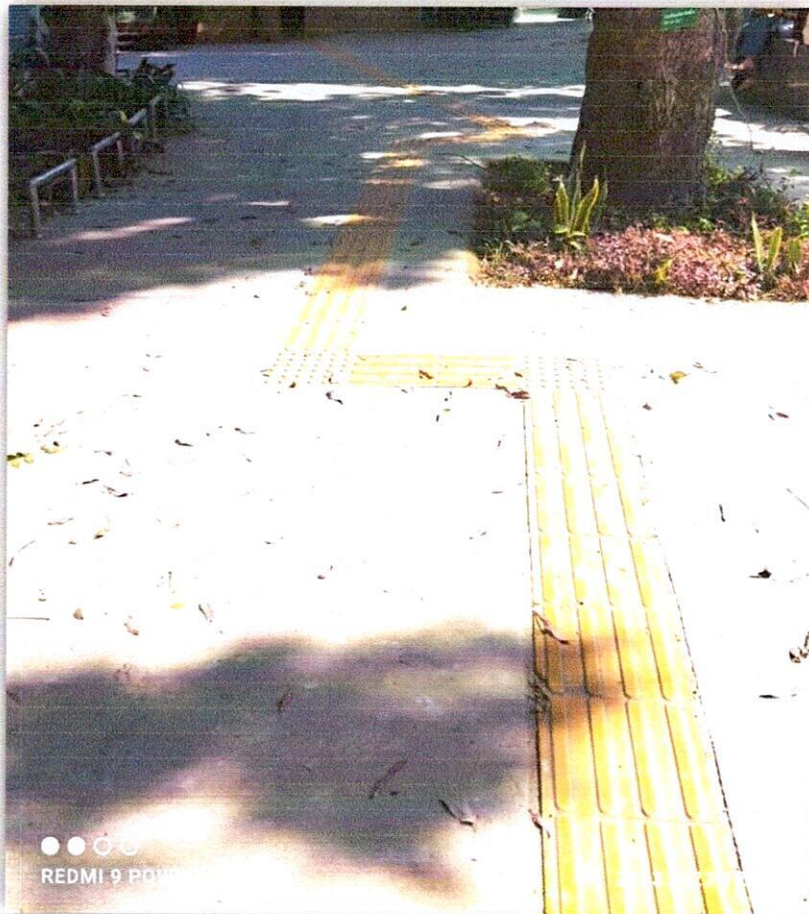
The office is accessed by one main gate meant for vehicular and pedestrian entry and exit. There is a security post at the main entrance gate. There is a pedestrian walkway in the office that is separated from the vehicular roads. Now the road is accessible for visually impaired people with a tactile path. But still, we found some broken holes that can be repaired, as well as signage and some places where tactile paths are missing.

Route with tactile

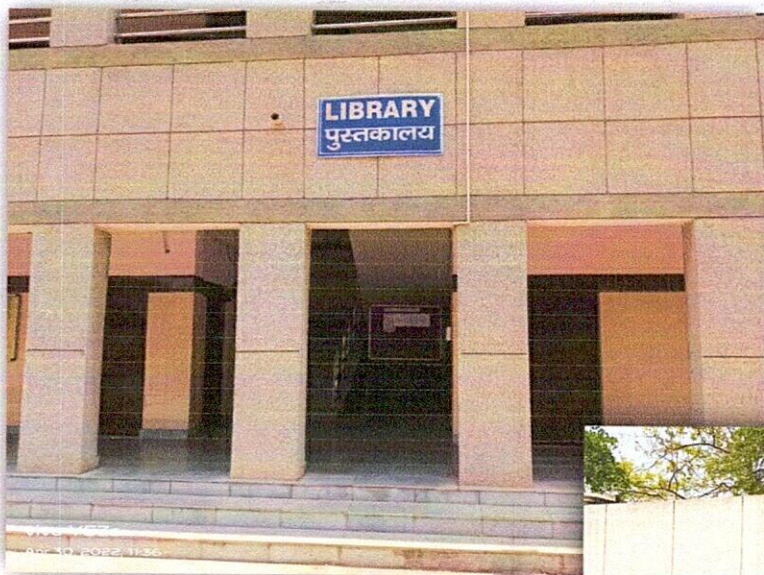
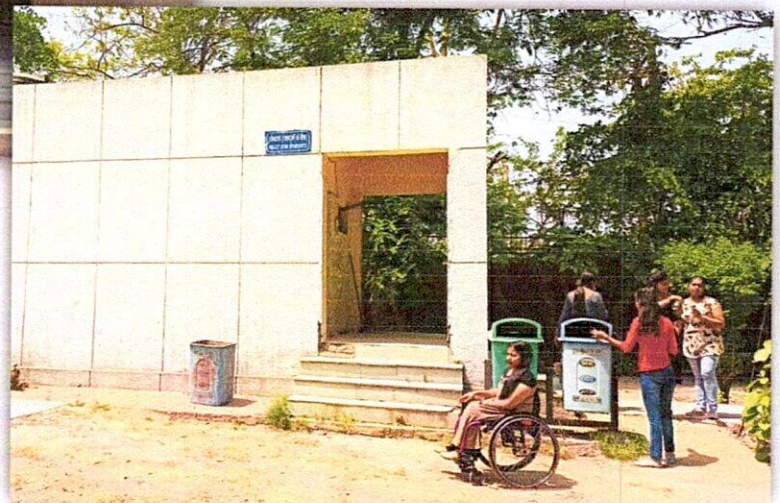
- International Standards for Symbols of Accessibility to be Installed
- The signage size and placement comply with the handbook specifications.
- **Audio signage, along with Braille and tactical signage, is missing.**
- All the signage is in high colour contrast.
- All the signage is well illuminated.
- **Visual and auditory public address system is missing**
- **Provide external signage's near entrance gate.**
- **Implementation as part of specific regular maintenance/renewal**

Signage's

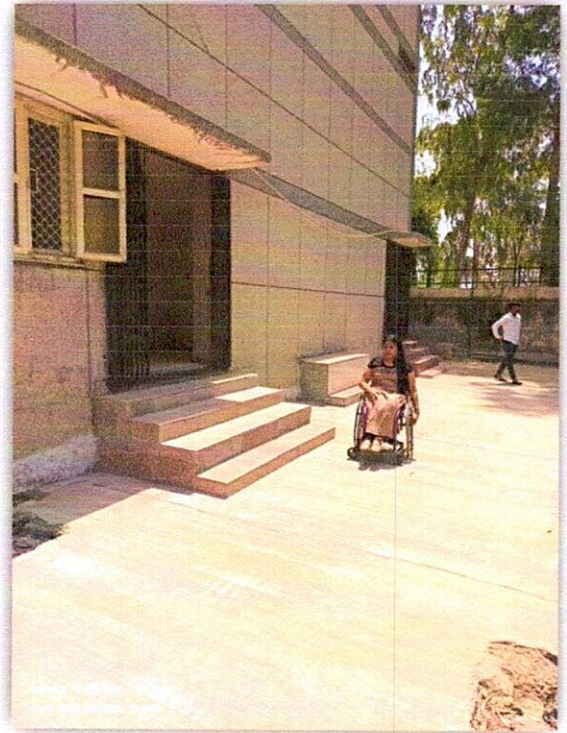
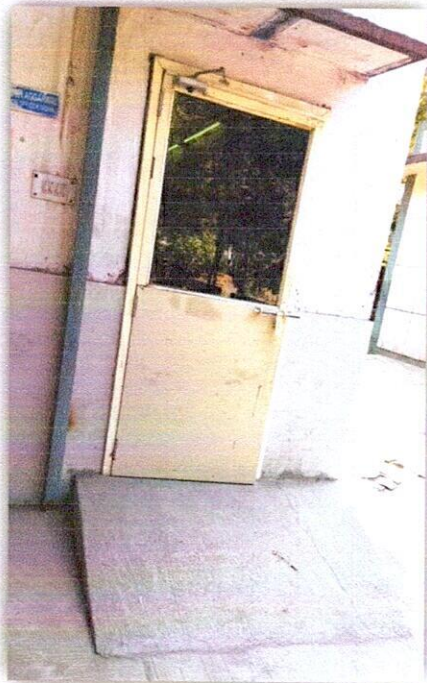
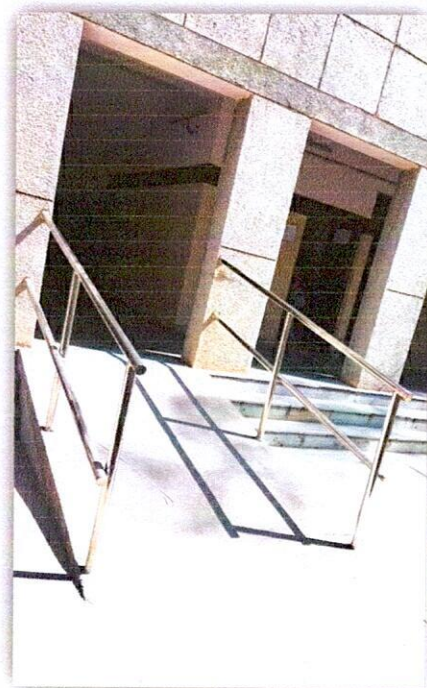
- There is no accessible identification signage to identify the entrance. Audio signals are also missing.
- Now there is an entry ramps in all premises like office, stage etc with both side railing as per the accessibility guidelines the gradient of ramp is 1:8 (standard 1:12 / 15 gradients.)
- Also there is no railing and no tactile marking to accessible for persons with disabilities in some ramps.
- Entrance area is illuminated.

Ramps with railing and without railing

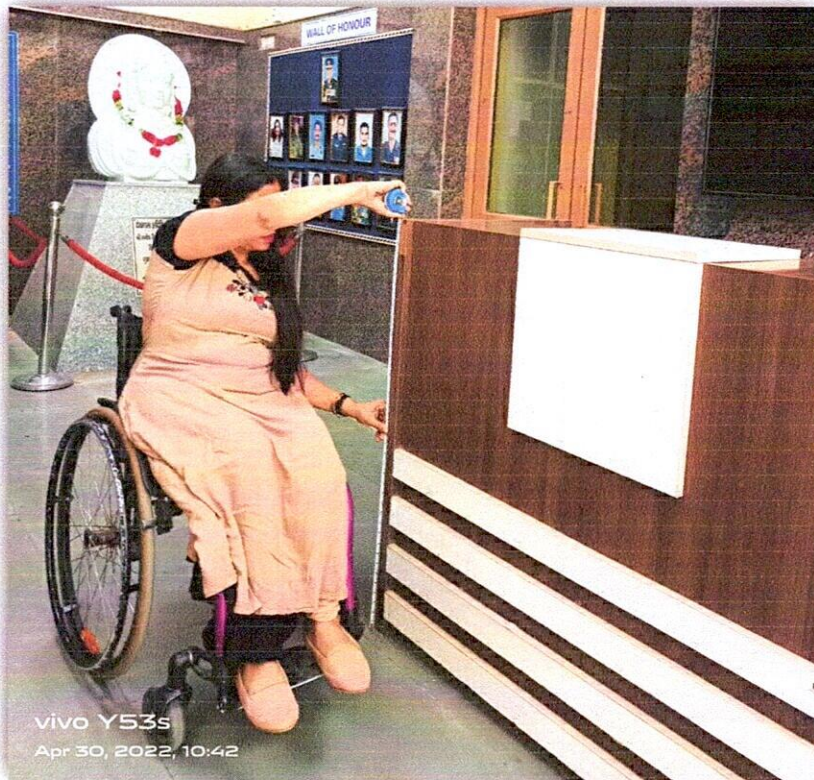
There is particular accessible reception counter at the entrance. There is no signage that leads to the reception and hence-forth to various building facilities. Also missing signage of department / unit name. The office also does not have Audio-Induction Loop and Accessible Printed Information for people with disabilities. There is no live assistance available at the counter to guide people to their destination. None of the staff are trained to communicate in Indian Sign Language.

Counter height 1100mm with no toe and knee space

Inaccessible reception counter

Note. Make reception counter as per audit report

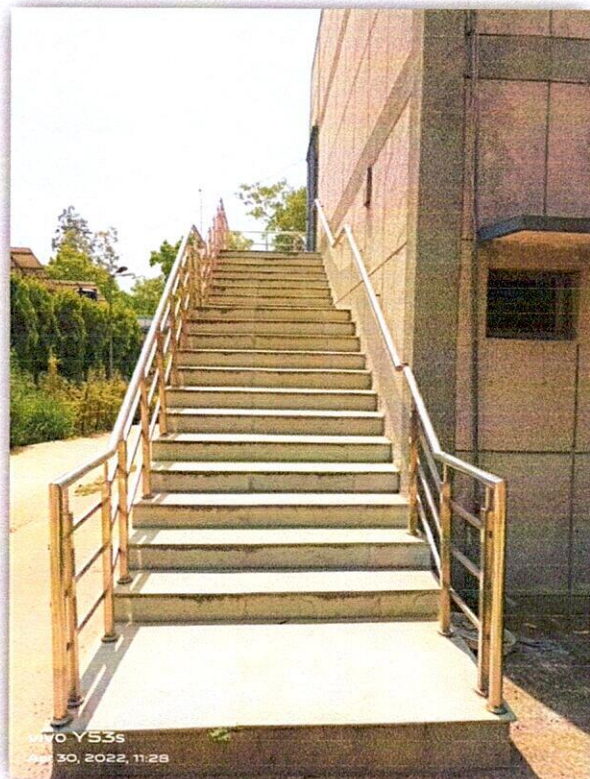
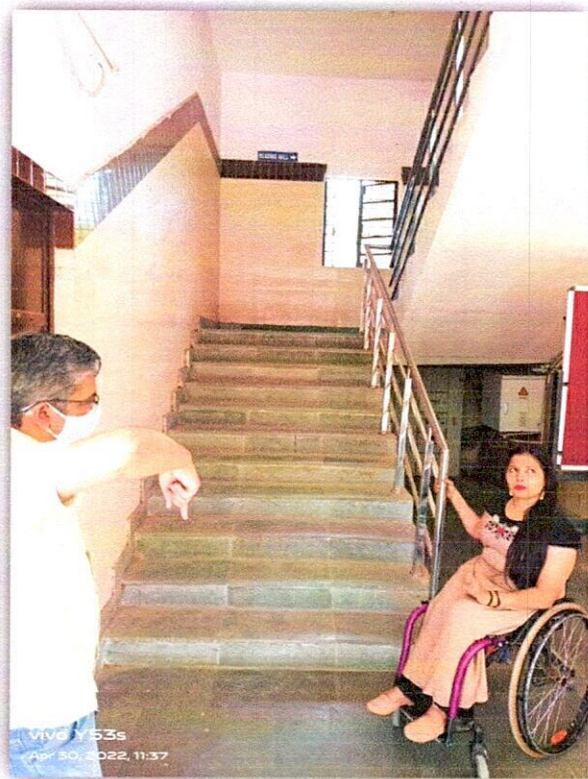
- There is different types of staircase and Color-contrasting strips not installed at the edge of the steps
- The steps in all stairs have uniform risers and treads of 150 mm and 300 mm respectively.
- The staircases are well illuminated but there are missing tactile floor guidance, color contrast strips at edges of steps and warning tiles at the beginning and end of each flight.
- Stairs are non slippery and non-glary and run straight and uniformly without any abrupt breaks or gaps in between them.
- Handrails not installed on the side of the walls have the desired minimum hand clearance of 50 mm between handrails and walls.
- The staircases flights have steel handrails on one side at a single height of, non-slippery, have uninterrupted grip and have no sharp edges.

Inaccessible Staircase

Note: Make staircase as per audit report.

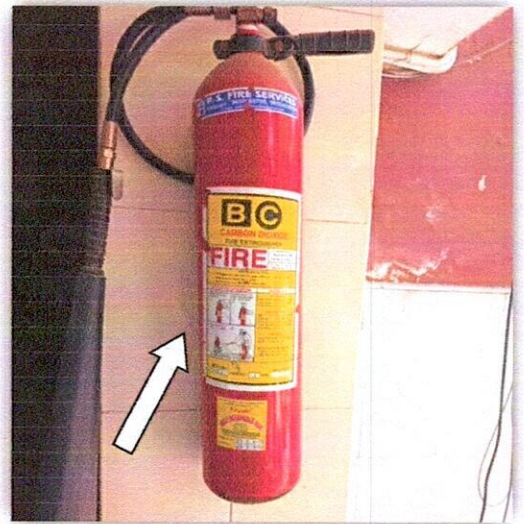
Emergency evacuation instrument was installed in building.

There is no emergency evacuation provision in the building. The building does not have any visual or audible alert system, nor is there any designated refuge area for persons with disability. Also, any kinds of emergency evacuation signage are.

Note: Emergency Evacuation system plan per audit report.

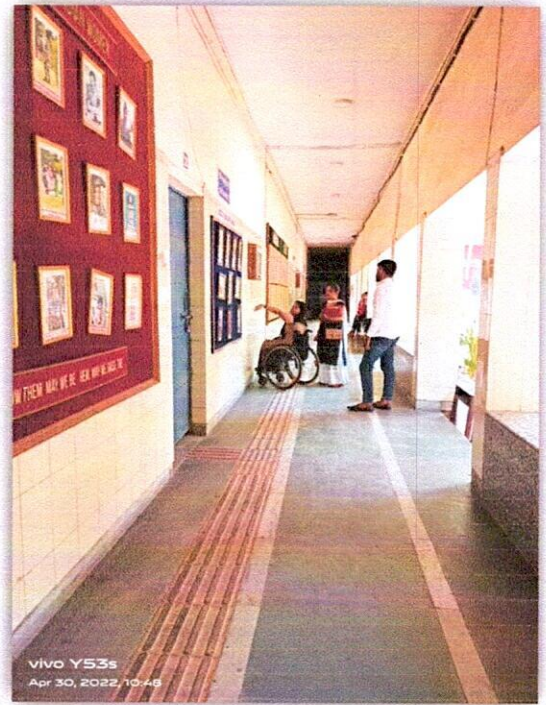
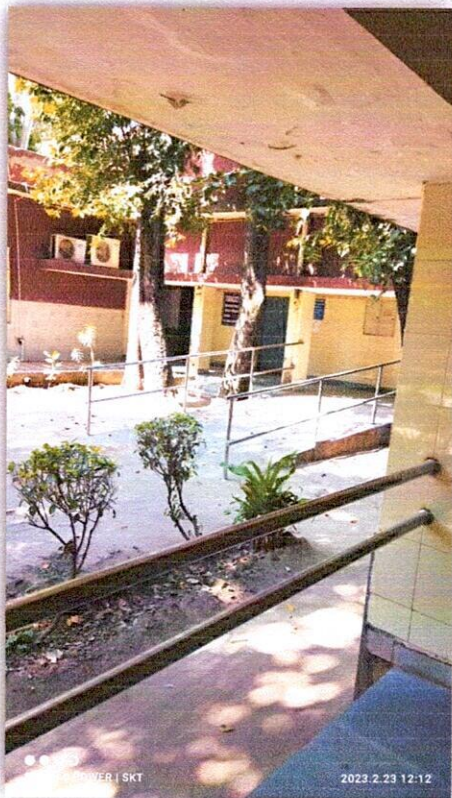
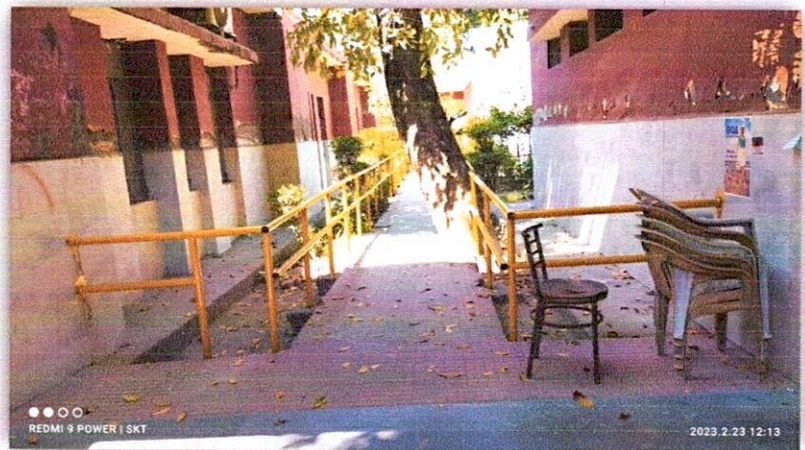
- The building has wide corridors and clear space for maneuverability and turning of wheel chair users.
- There is color contrast from the floors to the walls, doors and ceiling and the corridor floors are with heavy patterns.
- There was a handrail found in the whole building, particularly the corridors. We found tactile in some corridors which are useful for persons with vision impairment.

Corridors with handrails

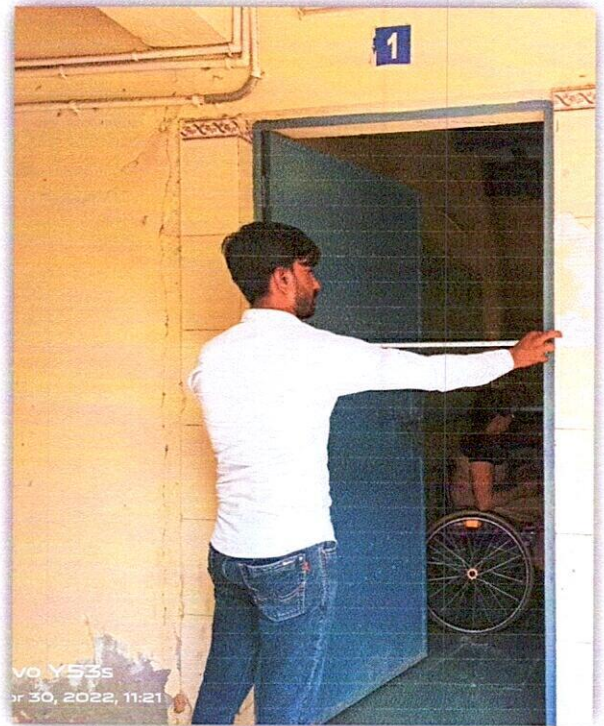
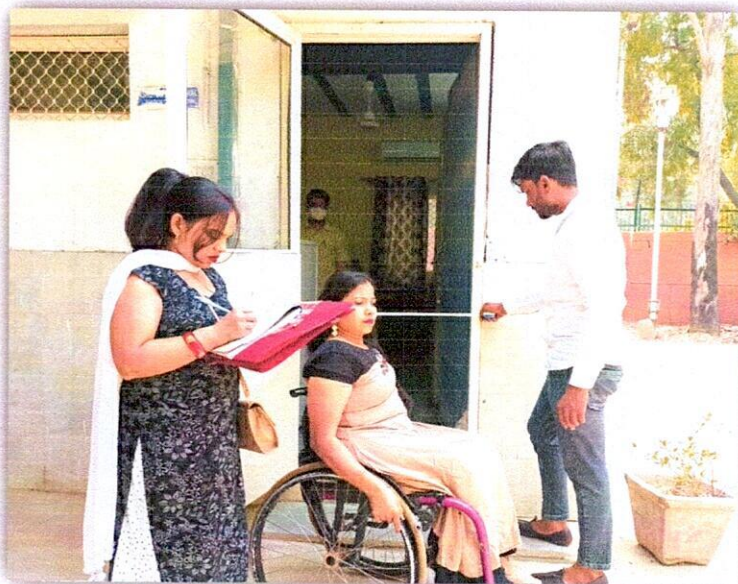
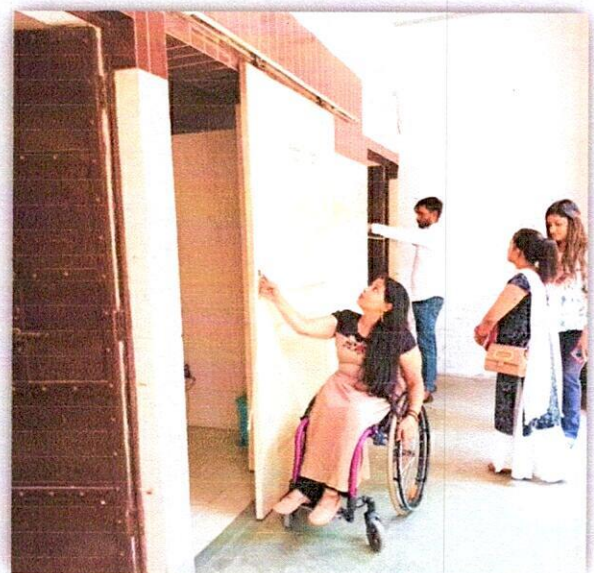
Some doors in the building not maintain a minimum of 1000mm opening. They are easy to operate and do not require a lot of effort. The building has single-hinged doors, which are push type doors which swing one way. Door handle height is 950mm. Doors open inward from the corridor including most of the toilet doors. All doors, doorframes, door furniture contrast in colour with the background wall. The doors do not have timed-release spring for shutting. All the doors are manual. There is sliding doors in toilet. Most doors have not enough space like toilet for a wheel chair user to operate it without any difficulty.

Doorways

Note: make doors as per audit report

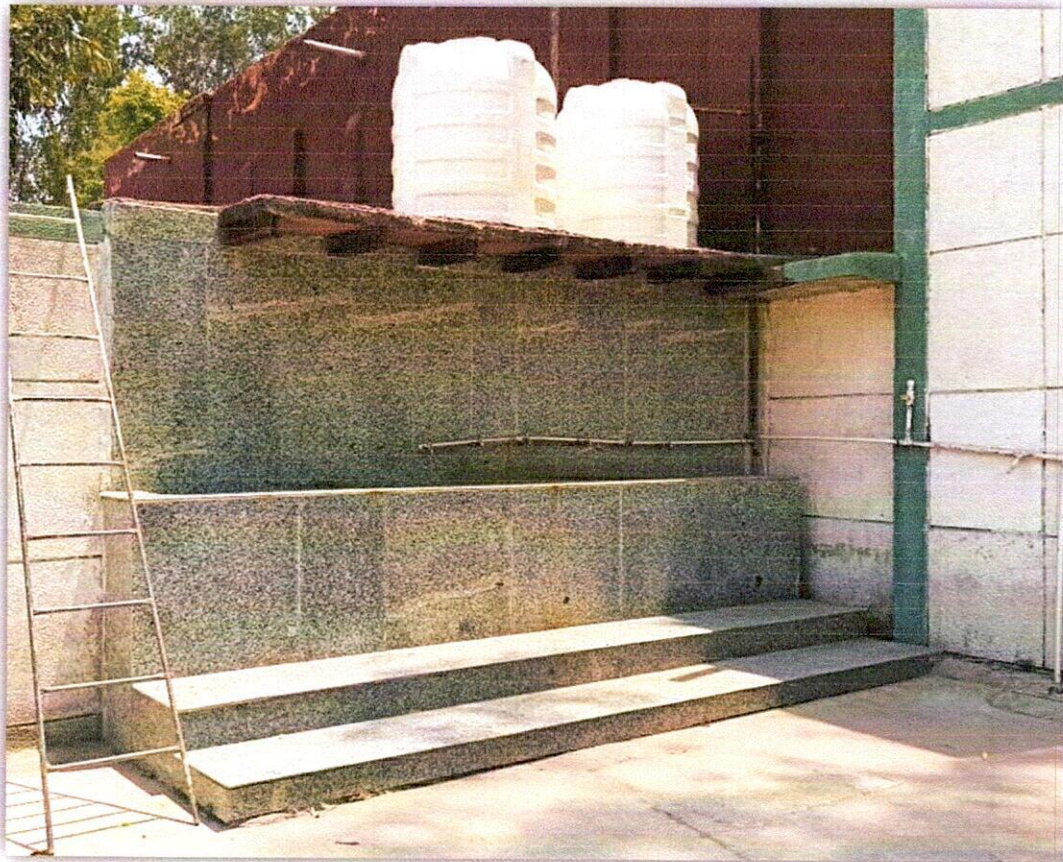
We found inaccessible drinking water facility with two steps

Note: make changes as per audit report

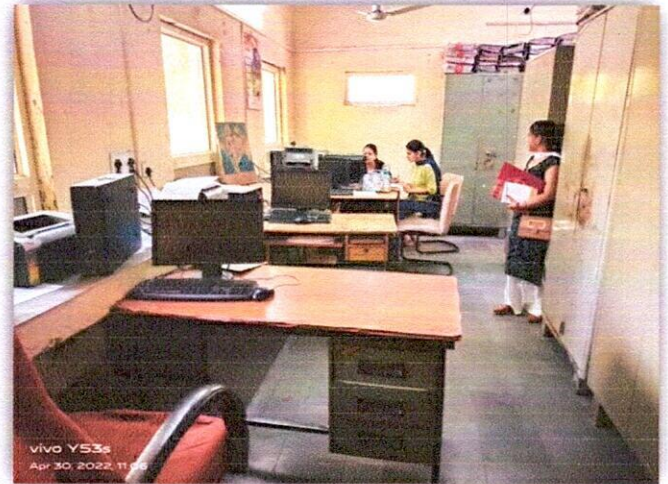
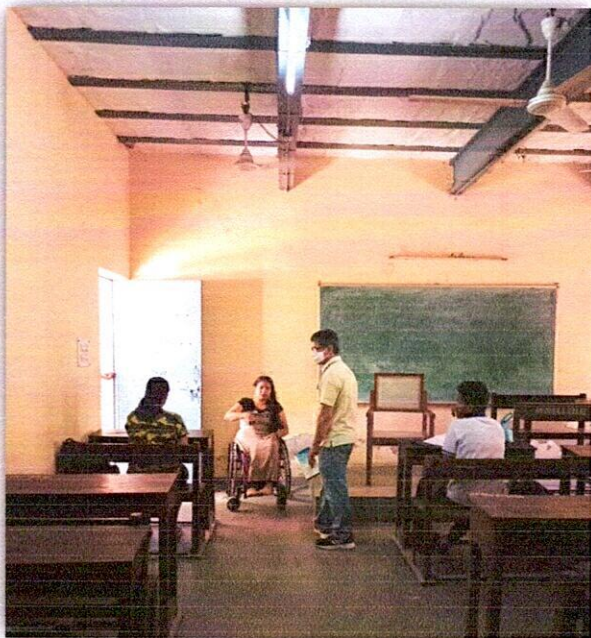
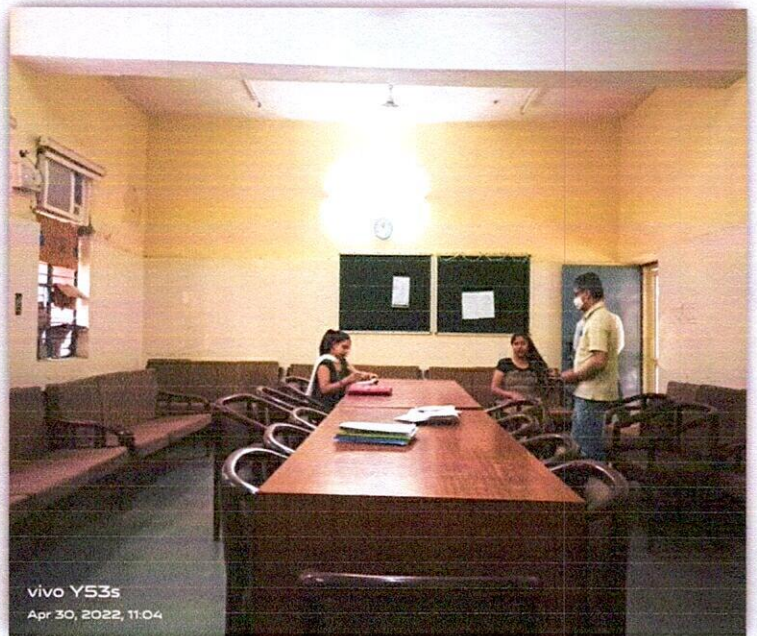
The furniture of different places was not according to the accessibility guidelines. (Table height 760 mm) some table with no toe and knee space, Circulation space in office was good. Switch board and thumb machine variable heights is 1100-1400mm.

Furniture in different place

Note: make changes as per audit report

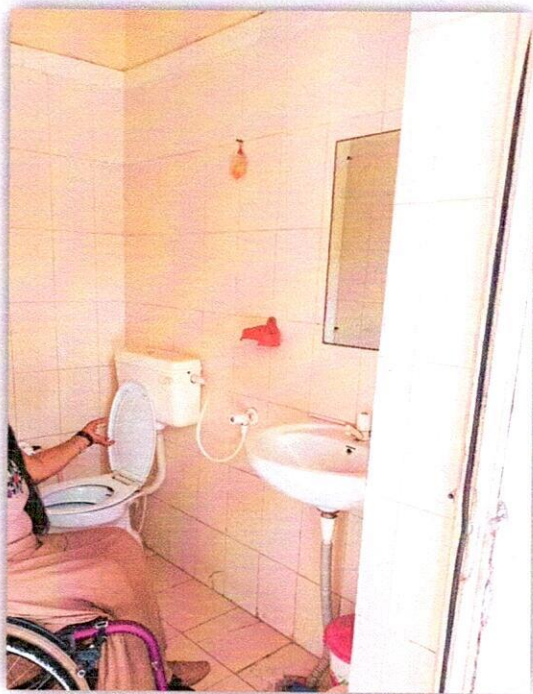
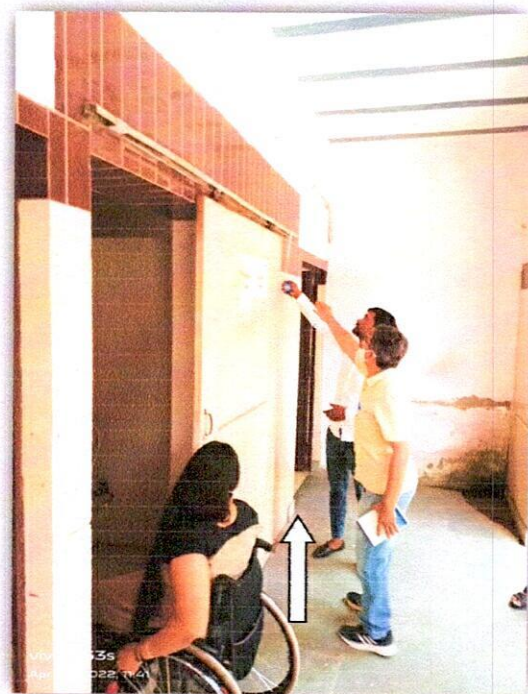
There is one accessible toilet for disabled person in the building, but not as per the guideline. Toilets has sliding door, door width more than 1000 mm, wash basin height 840 mm, mirror height more than 900mm, low circulation space in toilet, grab bars not fitted in toilet. The floor surface of the toilets is slippery. Toilets in office were in good condition & maintained. Toilets also do not comply with accessibility parameters in terms of size, colour, fittings, accessories, requirements for alarm systems etc.

Accessible toilet not as per guidelines

Note: make changes as per Audit report
